IMPROVED LONG-TERM PRESERVATION  
SYSTEM FOR SHIPS' TOPSIDES AND  
SUPERSTRUCTURES

Harold E. Achilles

Naval Ship Research and Development Center  
Annapolis, Maryland

Report 3927

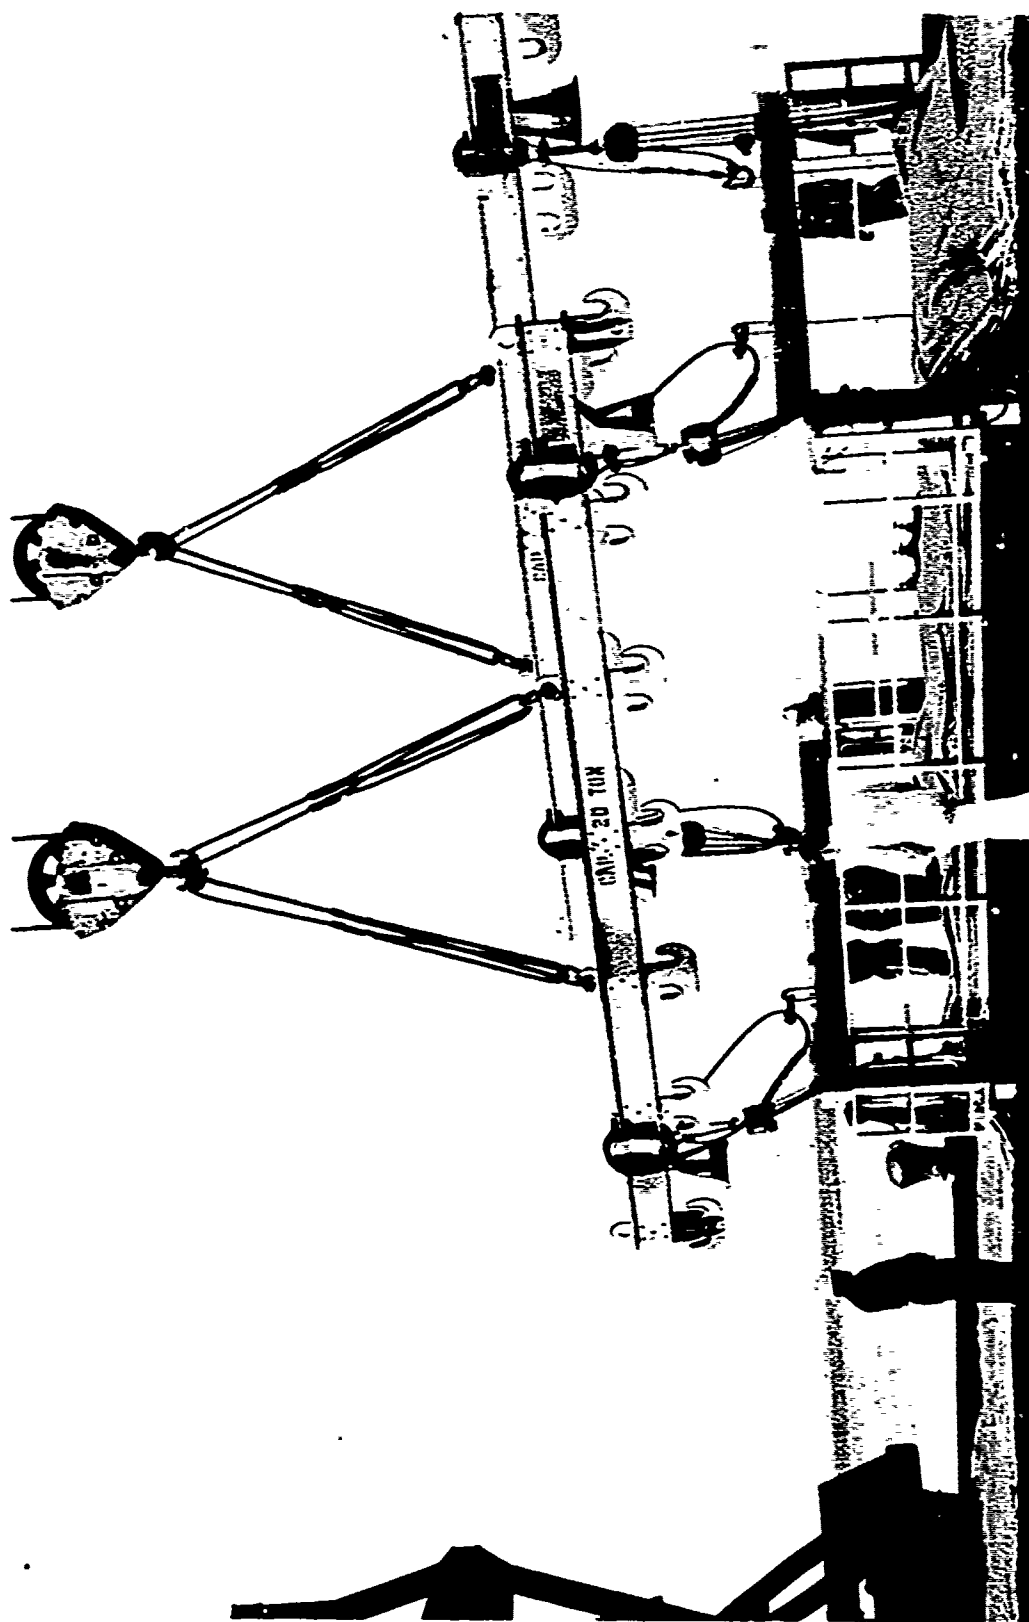
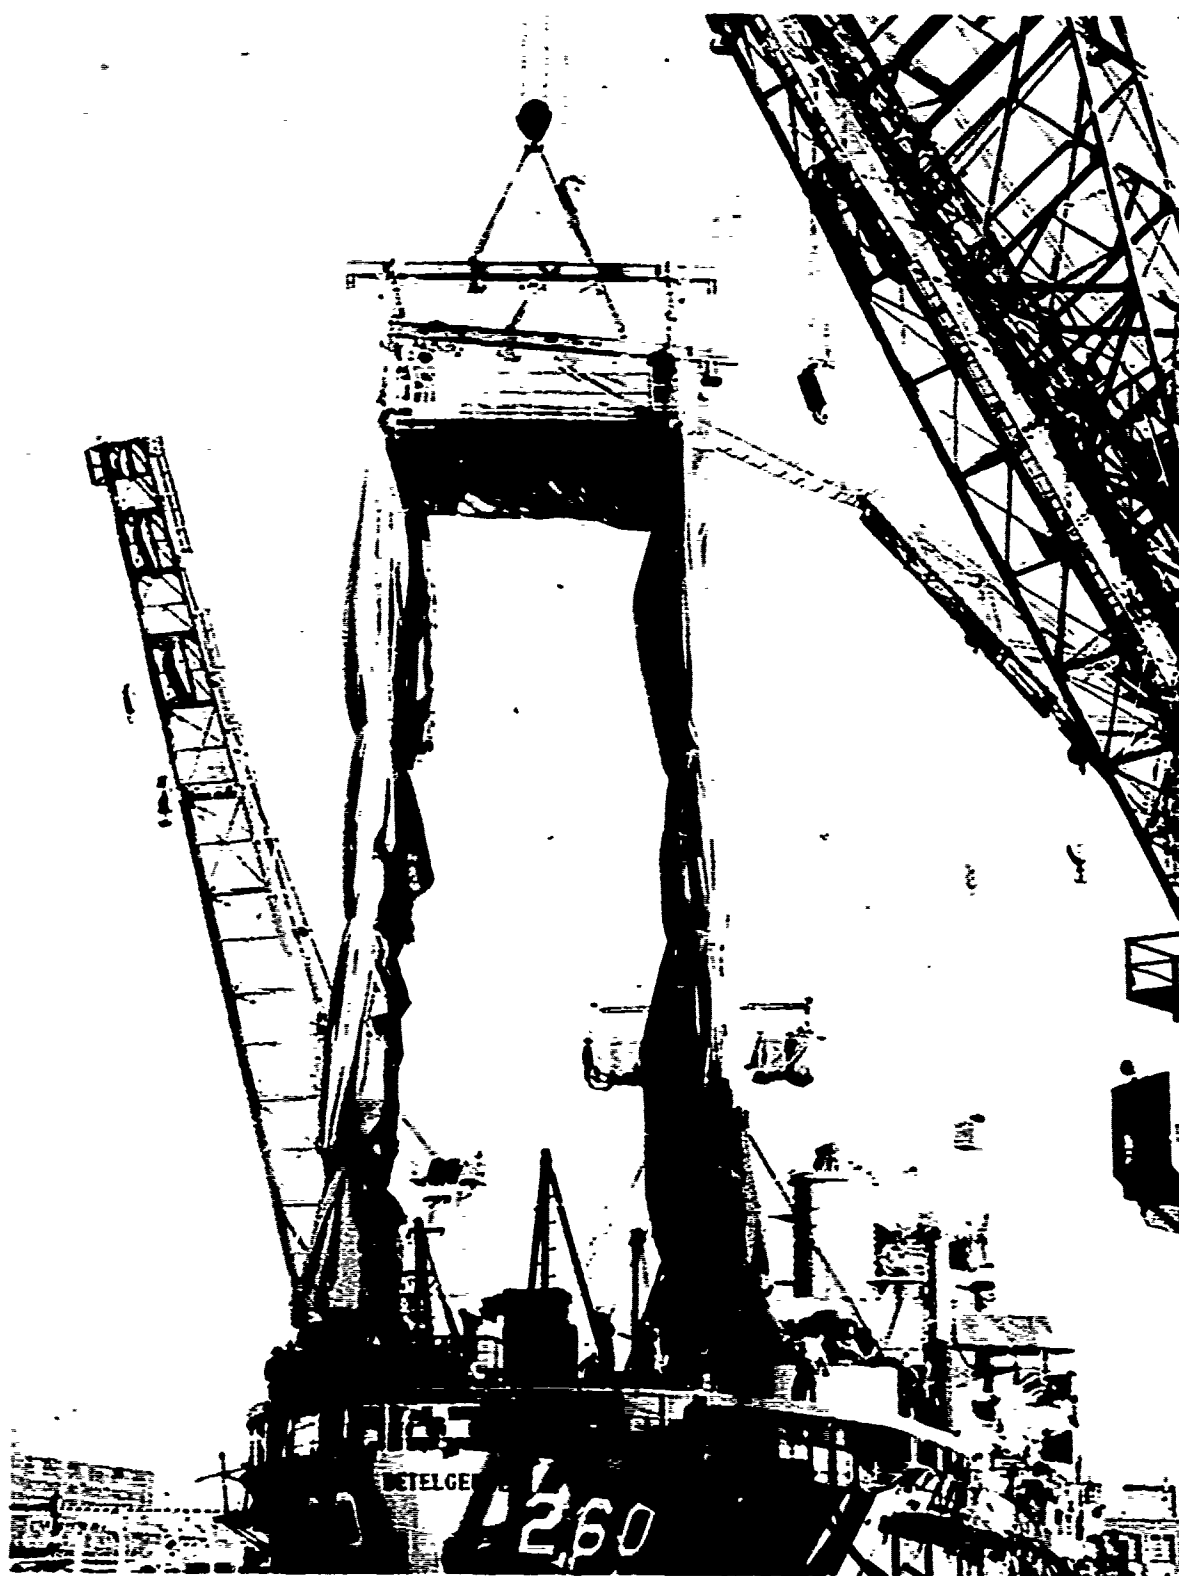
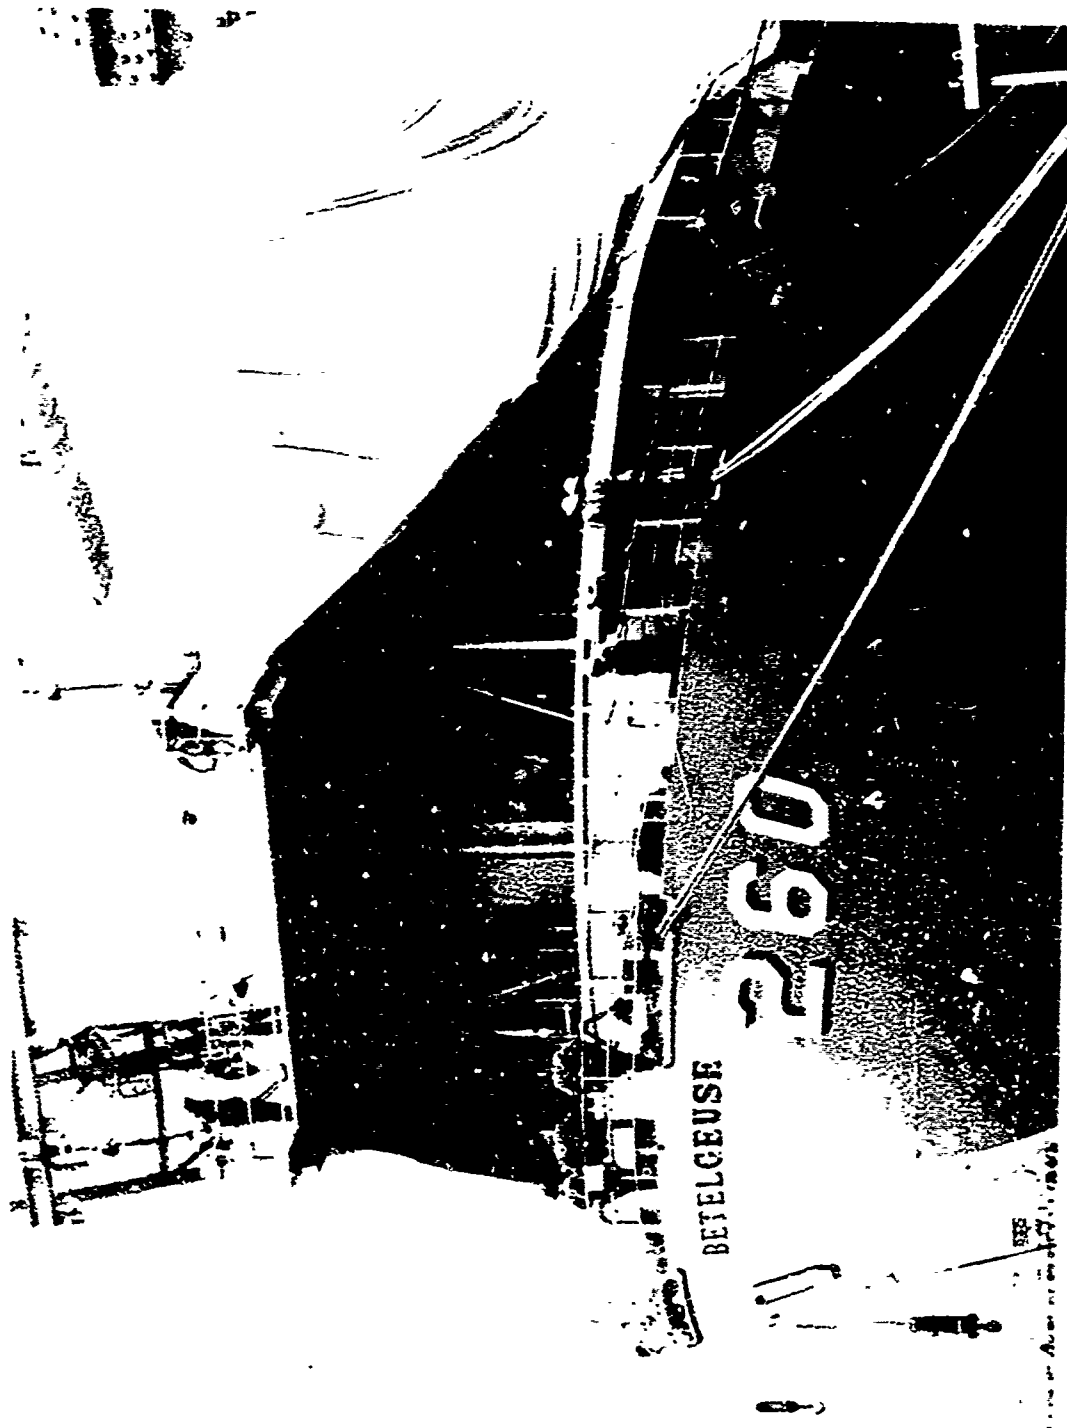
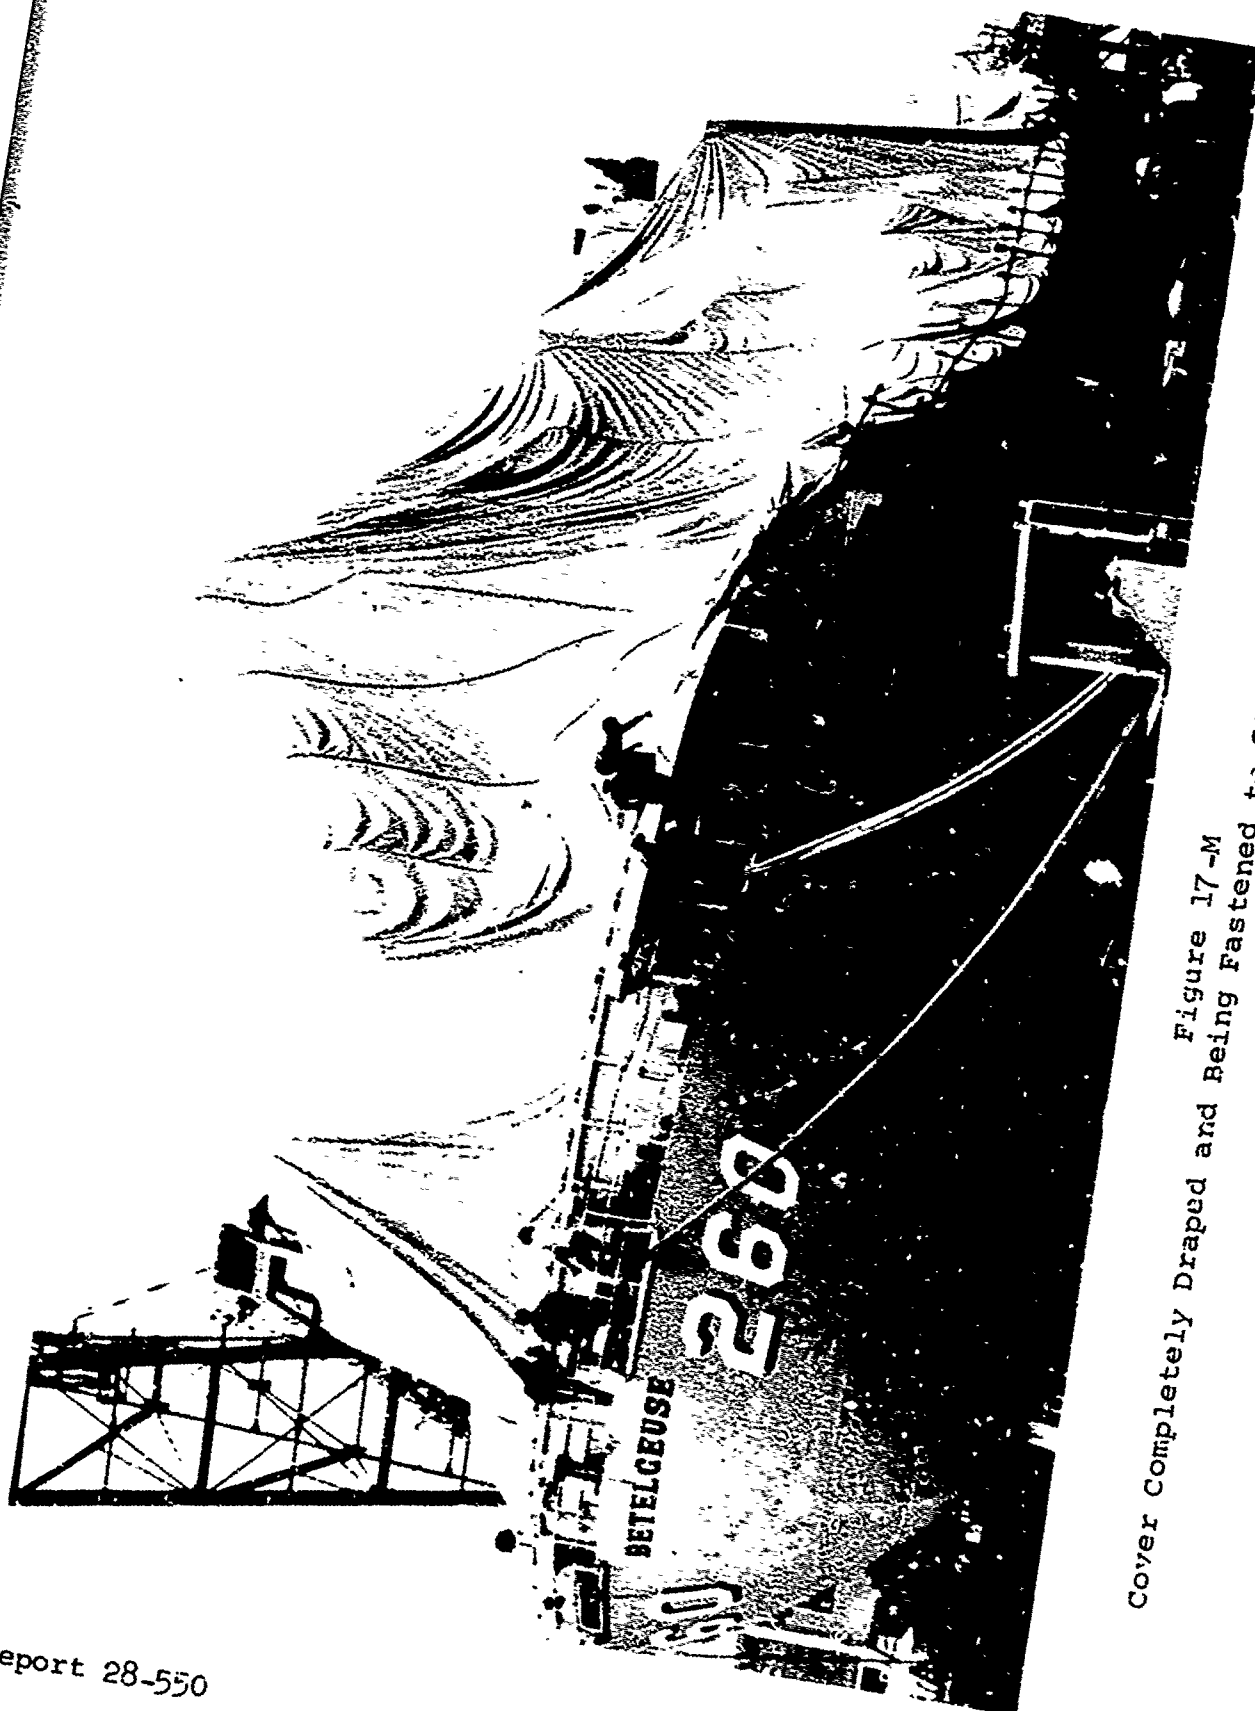
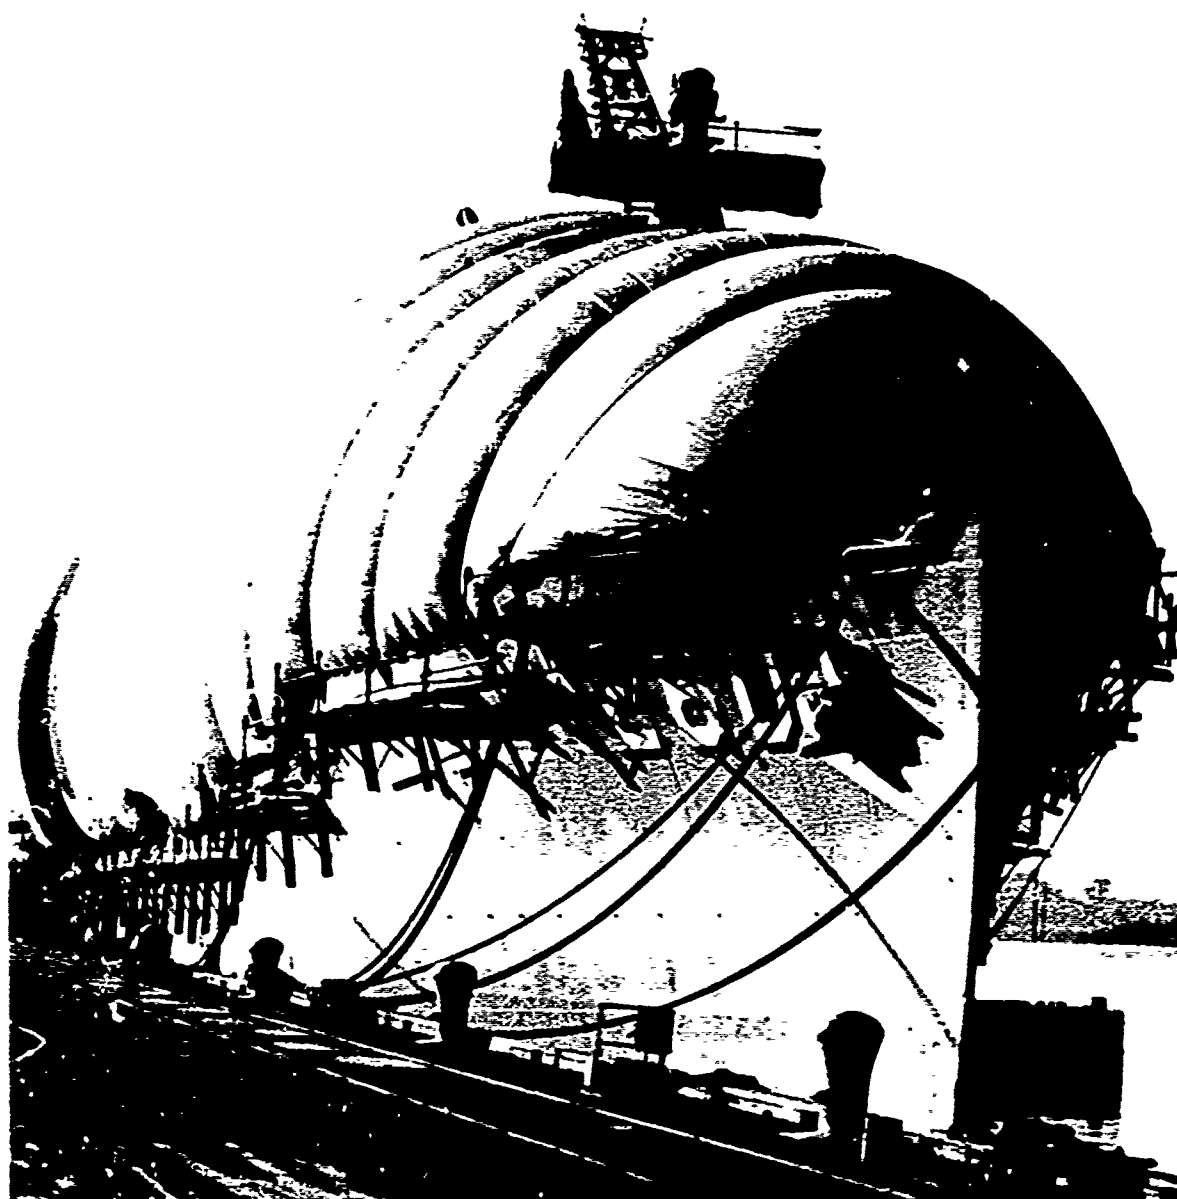
For several reasons, the installation date of the cover slipped to 18 October 1971. This was discouraging because local weather bureau reports indicated that blustery, changeable conditions could be expected on this date. Strong winds did occur then and it was necessary to postpone cover installation to the 19th. Unanticipated problems developed during the draping and fastening of the cover so that installation and preliminary inflation of the cover could not be completed until late on the 20th. Details concerning the problems which developed and their on-site solution are described on pages 57 through 63 of the final report.<sup>1</sup> Highlights of the installation of the cover appear in figures 9-M through 19-M of appendix M.

In view of the problems which had developed, a conference was held on the following day to solicit comments and suggestions which could expedite future cover installations aboard ships. Specific items recommended for further consideration are summarized in appendix B.
